# Alaskan Transportation

Local Technical Assistance Program

Winter 2002

## Late Autumn Kenai Peninsula Flooding Causes Significant Damage

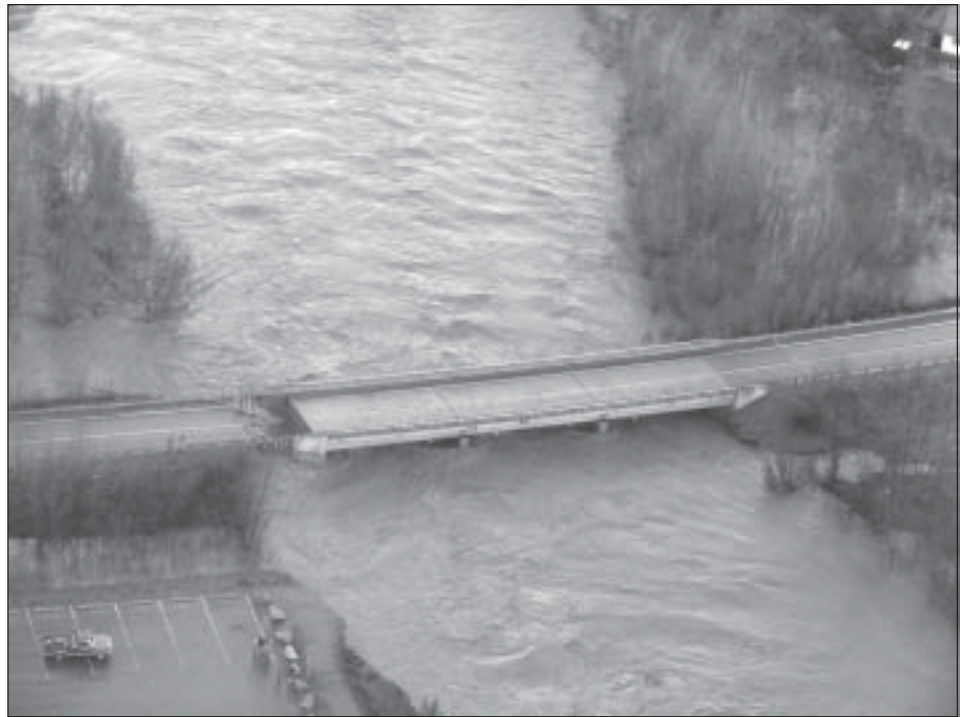
*Deep Creek bridge abutment failure on the Sterling Highway. Inadequate bank protection for a flood of this magnitude may be partially at fault.*

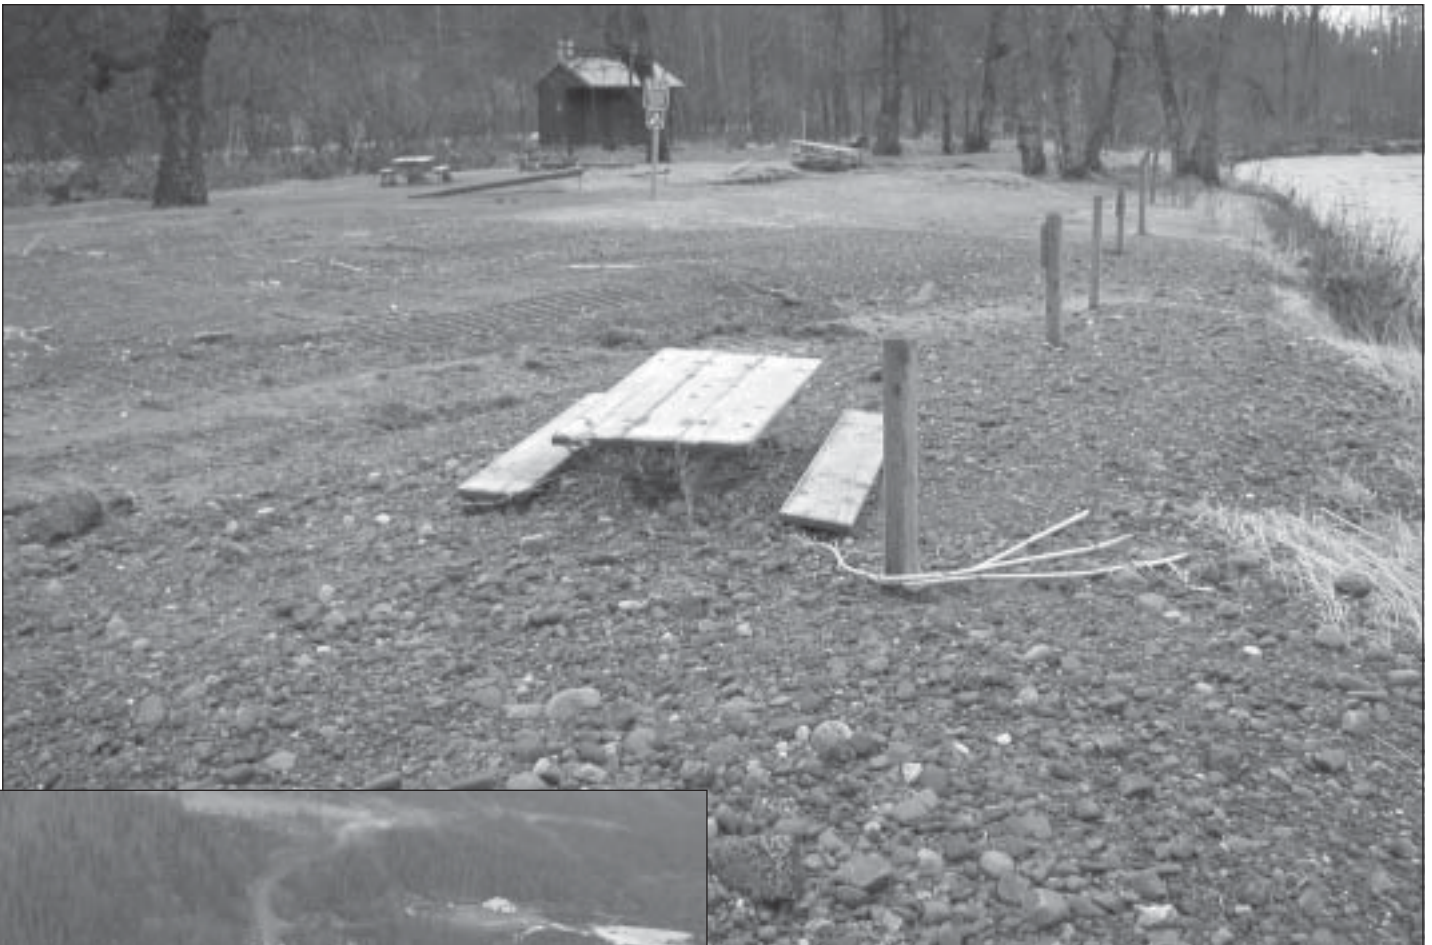
*Kenai River flood was no picnic! The photograph above illustrates bed load deposit covering the picnic table legs at the Silver King Campground on the Anchor River. Theft chains prevented the table from being washed downstream.*

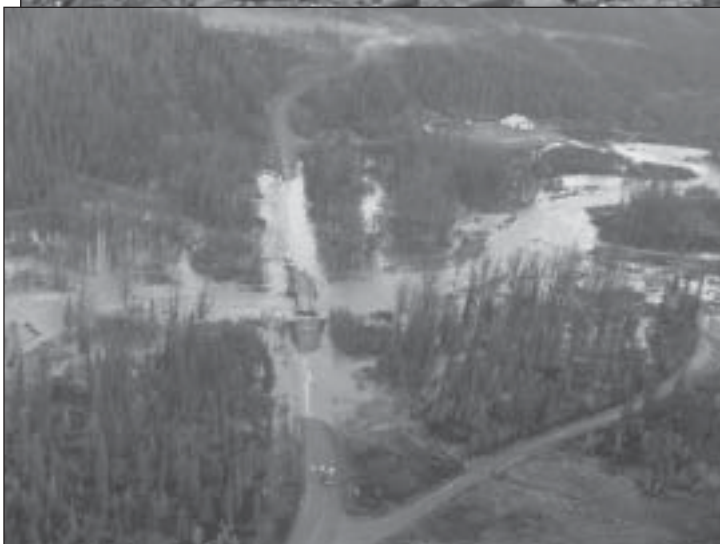
*The South Fork of the Anchor River engulfs the North Fork Road near Homer. If you look closely you'll see the bridge lost the south abutment.*

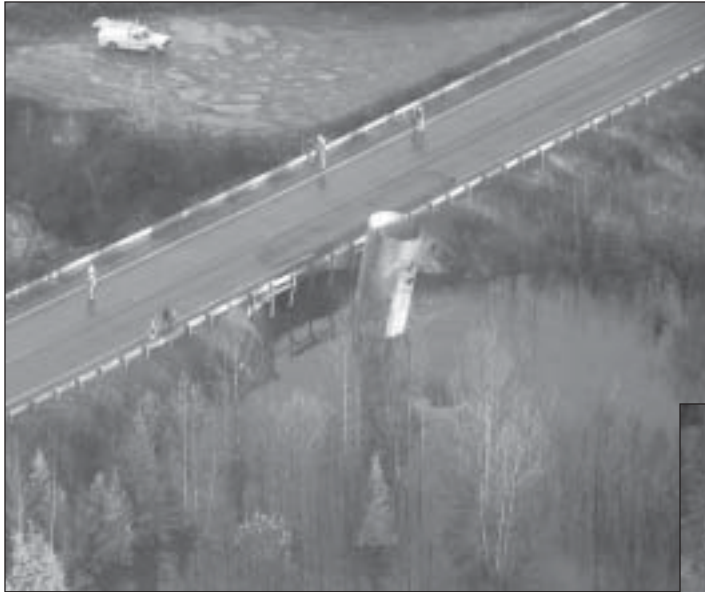
*The top photo shows culvert buoyancy failure on Stariski Creek on the Sterling Highway. (Buoyancy failures can occur when water backs up over a culvert, trapped air in the culvert makes the culvert act like a cork, popping out from under the embankment.)*

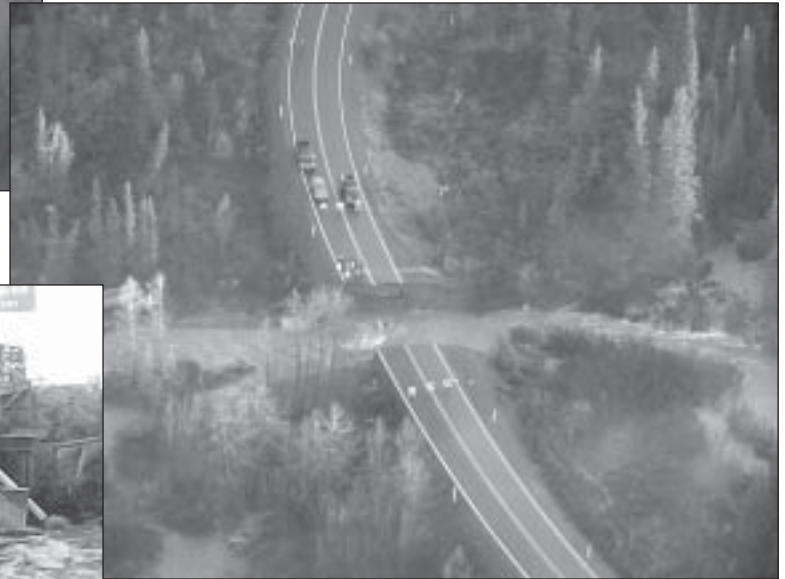
*The photo on the right shows the North Fork of the Anchor River where it flowed over the Nikolaevsk Village Road, resulting in culvert failure and road wash out.*

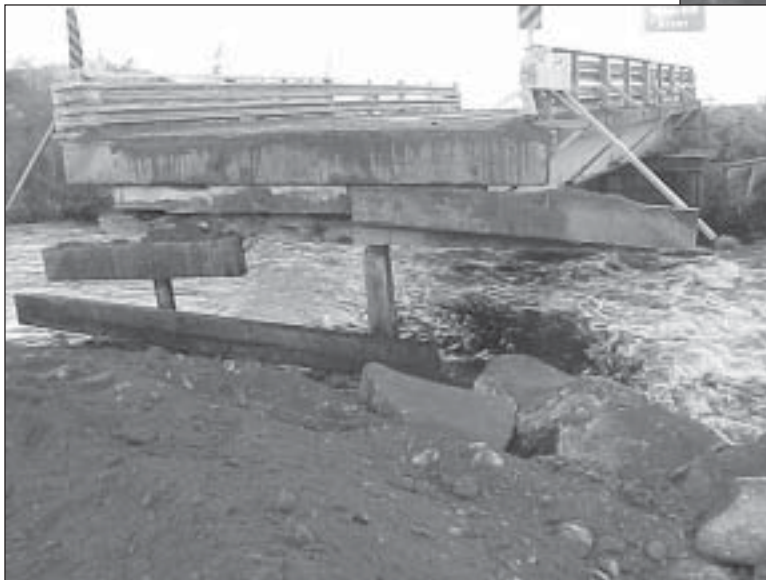
*Bottom left photo: An obvious abutment failure left the Ninilchik River Bridge precariously balanced on two timber columns. Mission Village Road access was reestablished and the bridge was miraculously salvaged.*

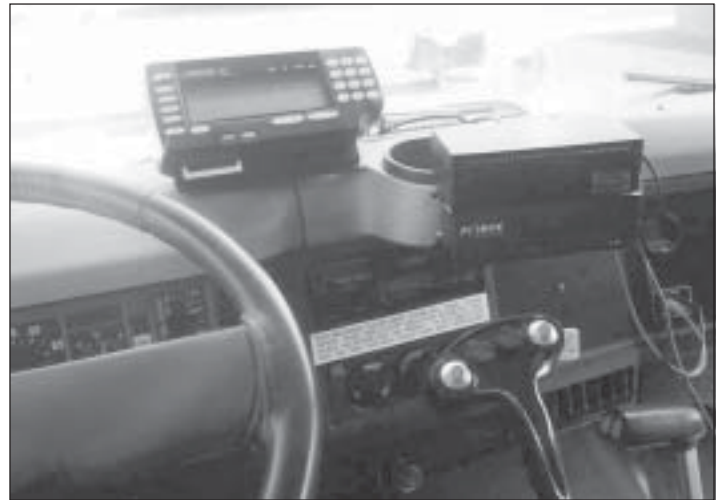
Figure 1: View of Mobile Data Collector in a Snowplow

ThomTech Designs, Inc. connects mobile data computer (MDC) to the sprayer or spreader controller in the snowplow/spreader truck. Sensors for pavement temperature, air temperature, and plow proximity are connected to the MDC. The interface also includes a global positioning System (GPS). As the truck moves about the road network plowing snow and spreading or spraying ice control materials, the MDC records the truck's position, speed, date, time, pavement and air temperature, and sand/salt/MgCl application rate. All data can be transmitted wirelessly or stored on a PCMCIA card for subsequent download to a central office computer. Figures 1 and 2 show the MDC and its connections.

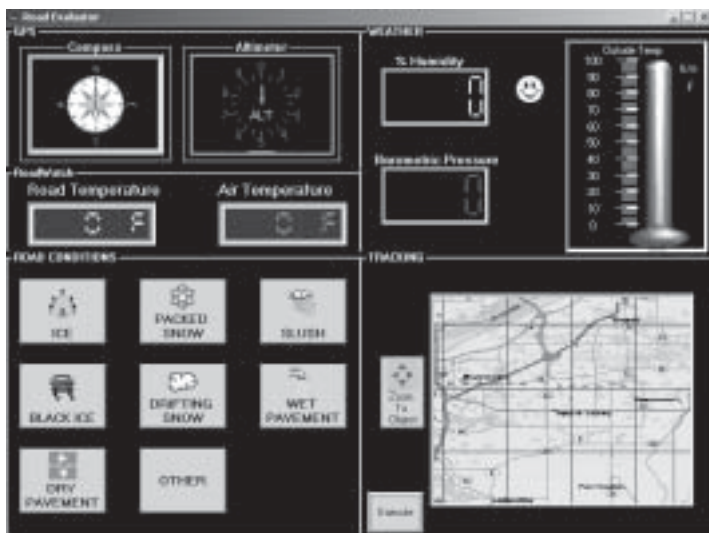
Figure 3: Screen Shot of Evaluation Software

In consultation with Southeast Region AKDOT&PF Maintenance staff, ThomTech Design, Inc. customized the evaluation software for the evaluator's laptop to record conditions typically found on roadways in Juneau Alaska. The research team decided to make evaluation descriptions as objective as possible, to provide a clear basis for decision-making. The evaluation laptop will also be connected to a digital camera to provide photographic documentation of road conditions. Additionally, the software will provide a warning to the driver of frost danger using the information from the pavement temperature and humidity sensors.

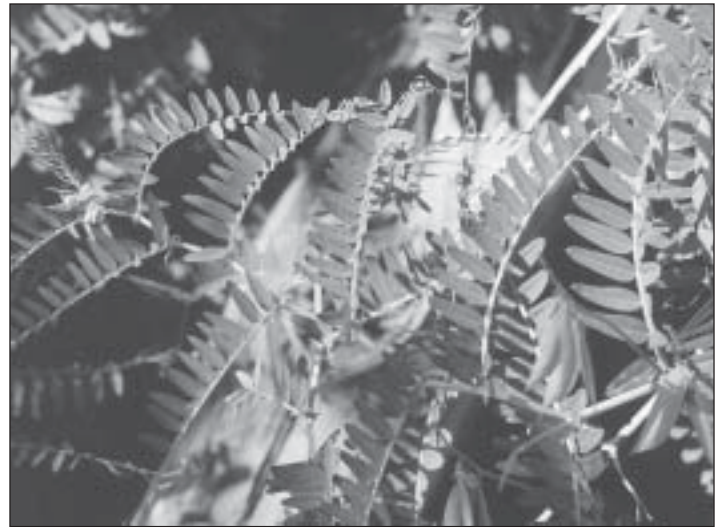
Vetch (*Vicia cracca*) Photo © Markku Savela

- 7 to 10 pairs of leaflets per leaf
- Trailing, vine like growth habit, usually forming a tangled mat or cluster
- Leaves terminating in tendrils
- Leaflets with non-distinct mid-vein
- Leaflets covered with silky hairs
- Flowering period from about July 1 until freeze up
- Bluish-violet or purple flowers
- Weak stem
- 15 – 40 flowers formed per cluster
- Seeds formed in pods similar to a pea

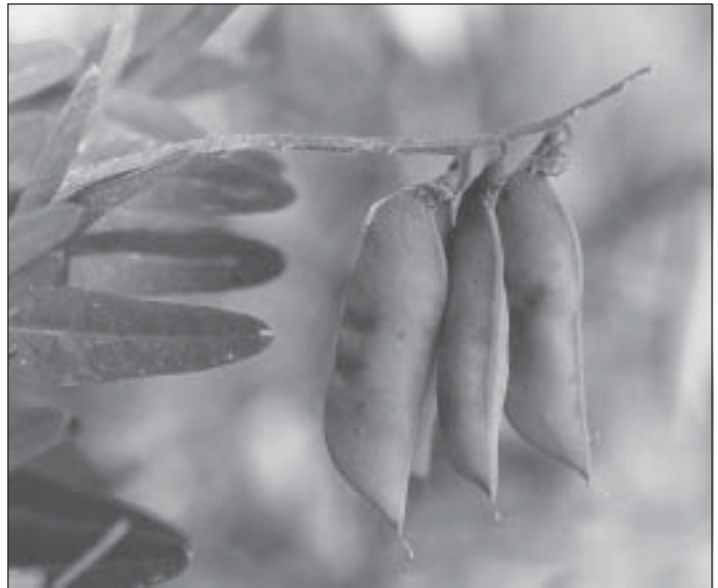
Photo © Markku Savela

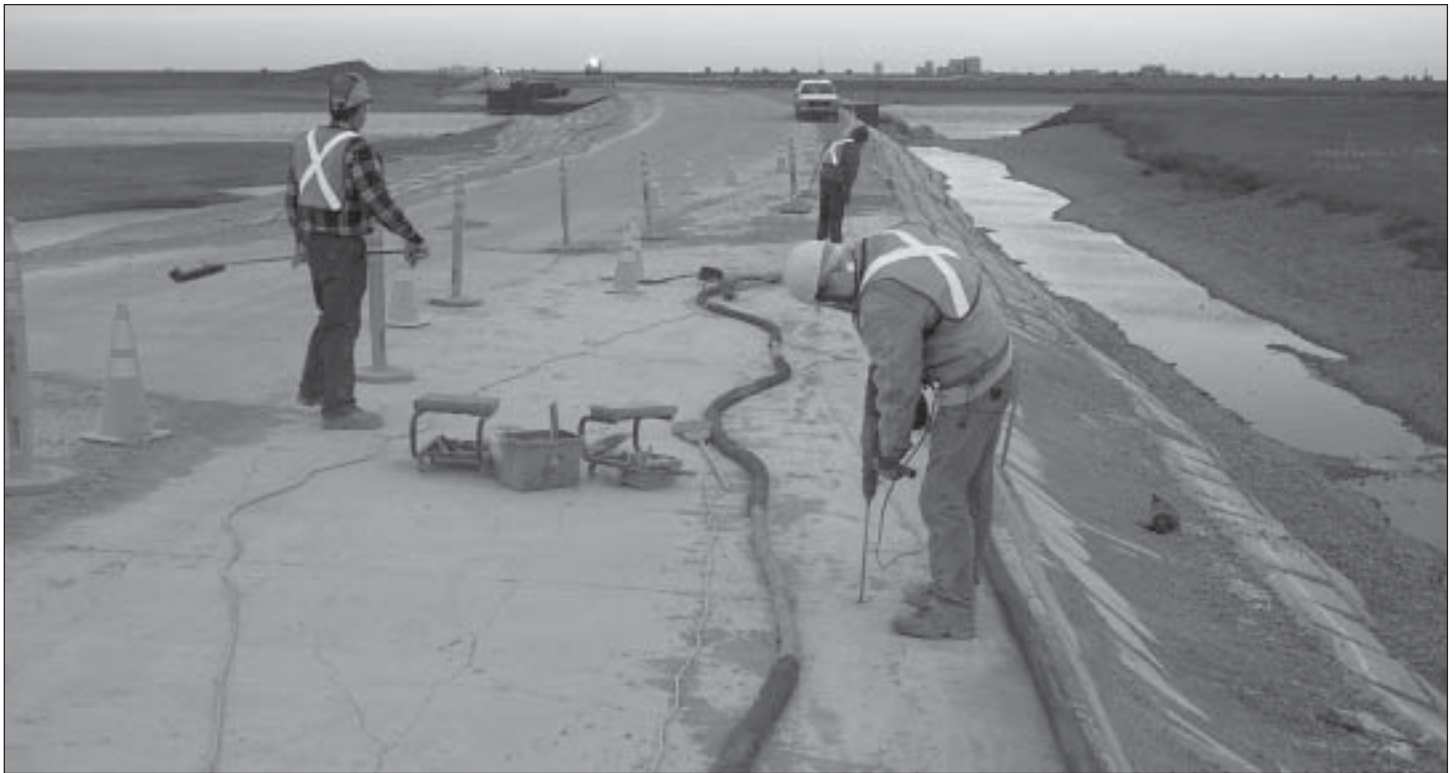
*The URETEK method successfully lifted the roadway several days ahead of schedule.*

Immediate repairs were necessary on the Kuparuk River East Channel Crossing. Thaw settlement of the fill and sloughing of a steep shoulder caused portions of the roadway to settle up to 13 inches. Such a large subsidence was making it difficult to move large drilling equipment along the heavily traveled Spine Road and hampering access to the western oil fields. Phillips decided to lift the pavement and level the road.

The engineering firm Peratrovich, Nottingham and Drage, Inc., recommended the URETEK method and Swalling Construction, Inc. was awarded the contract. The URETEK method employs high density expanding synthetic resins (expanding foam) to fill, densify, and stabilize low density compressible soils. The process was used to gently lift the slab six days ahead of schedule to the satisfaction of Phillips Alaska.

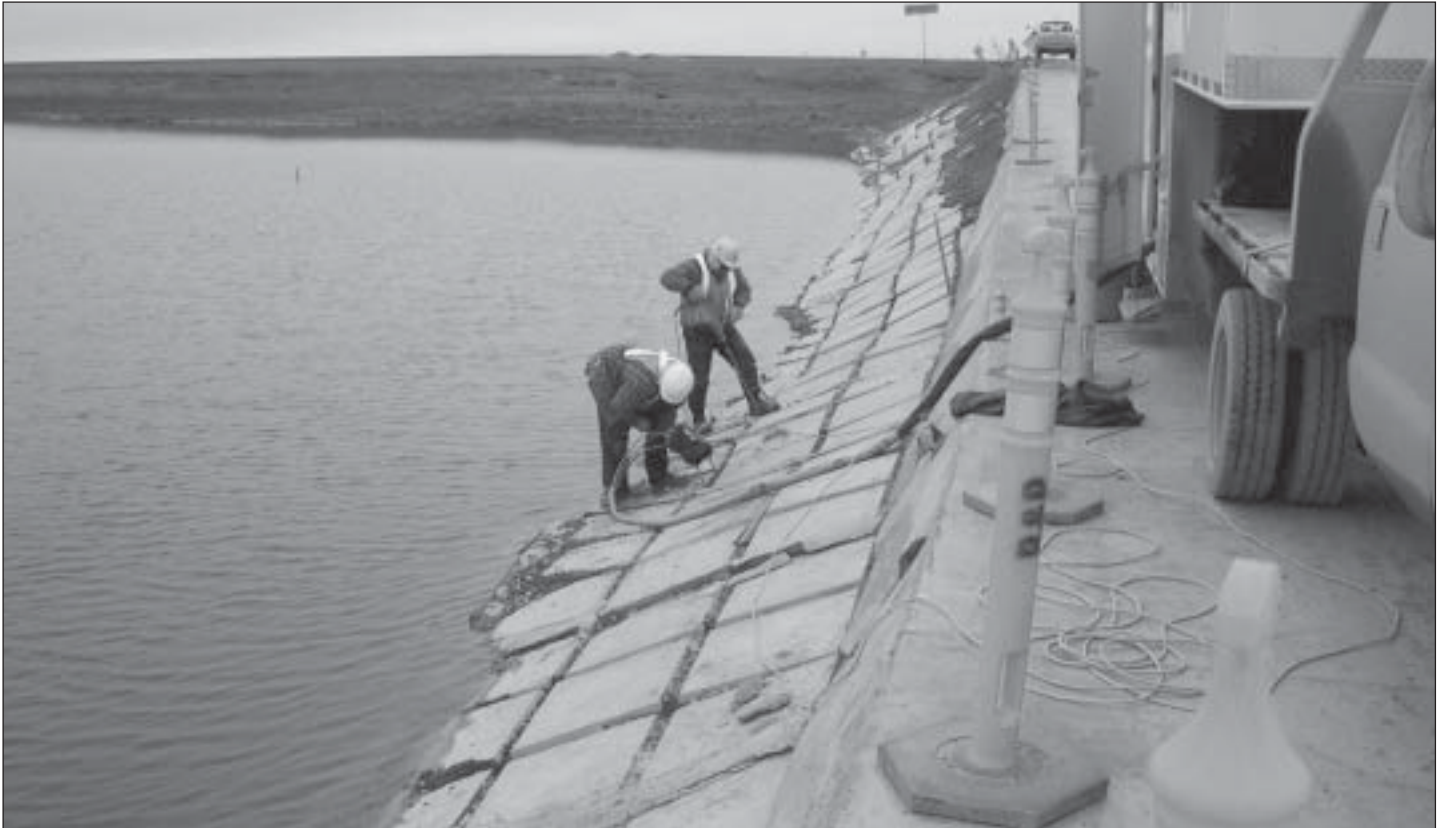
*Contractors work to raise the revetment and stabilize the sideslope.*

Deep injection was also used to stabilize the sloughing road sideslope under several rows of revetment. The revetment was raised in short order and gravels underneath amalgamated forming a water resistant barrier. Deep injection was utilized to attempt sub base densification for increased load bearing capacity.
